**Flood Control Project Maintenance
Levee Inspections**

Fall 2013 Levee Maintenance Deficiency Summary Report

Reclamation District No. 2058 Pescadero

Waterway			Bank	Unit Miles
Unit No. 01 Paradise Cut			Left	6.71
	Spring (March - May)	Summer (June - August)	(September - November) Fall	Winter (December - February)
Unit Maintenance Rating (Fall Only)			M	
Date of Inspection	05/22/2013 - 05/22/2013		10/29/2013 - 10/29/2013	
DWR Inspector	Maksim Khashchuk		Maksim Khashchuk	
Accompanied By	Greg Pombo		Greg Pombo RD2058

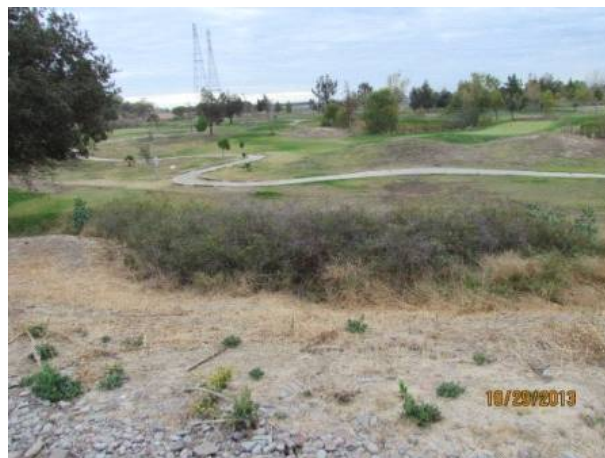
Levee Mile Report Line	4
Start Levee Mile	0.23
End Levee Mile	0.23
Location	Land Side
Category	Earthen Levee
Item	Vegetation

View of the wild rose habitat for the brush rabbit.

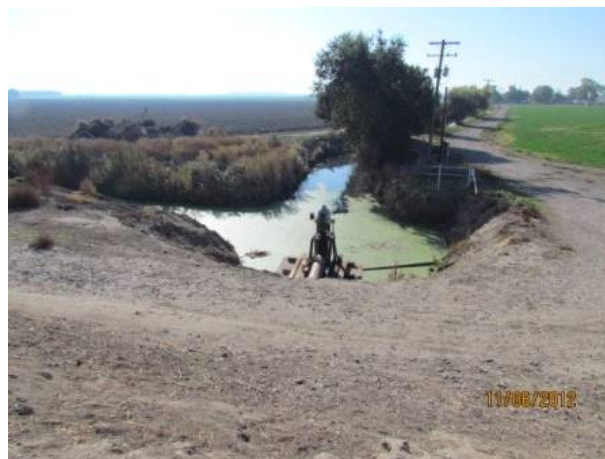
Levee Mile Report Line	7
Start Levee Mile	0.72
End Levee Mile	0.72
Location	Land Side
Category	Earthen Levee
Item	Encroachments

View of discharge pipe on landside slope.

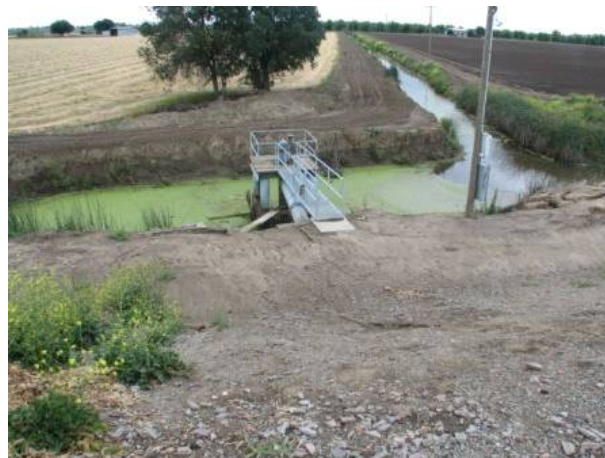
Levee Mile Report Line	8
Start Levee Mile	1.24
End Levee Mile	1.24
Location	Crown
Category	Earthen Levee
Item	Encroachments

Drainage discharge to Paradise Cut.

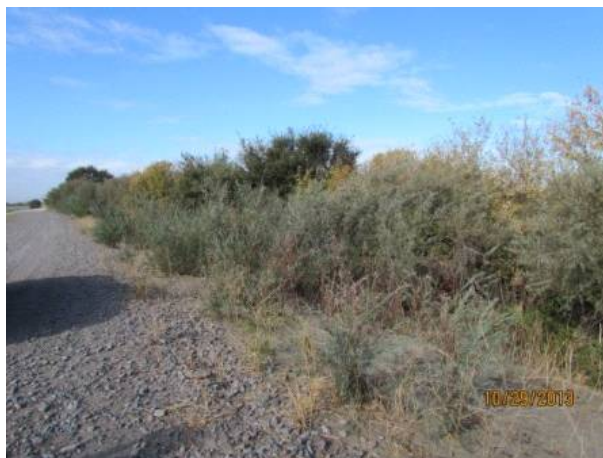
Levee Mile Report Line	9
Start Levee Mile	1.72
End Levee Mile	1.78
Location	Water Side
Category	Earthen Levee
Item	Vegetation

View if the overgrown vegetation on the waterside slope to be removed.

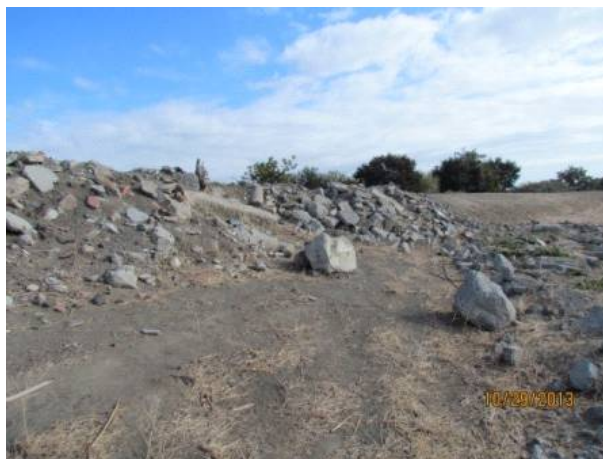
Levee Mile Report Line	10
Start Levee Mile	1.84
End Levee Mile	1.84
Location	Land Side
Category	Earthen Levee
Item	Encroachments

View of the concrete with rebar placed on the landside slope.

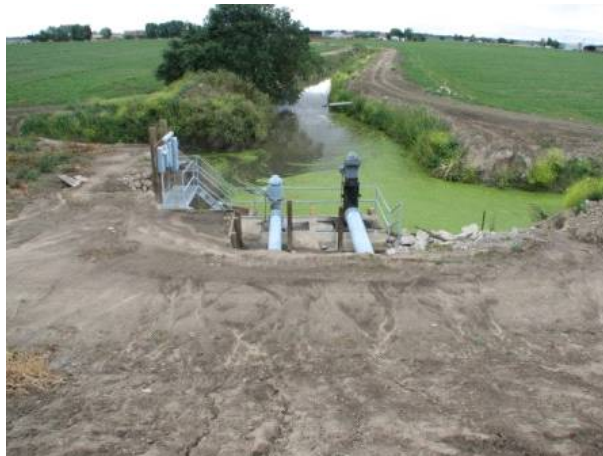
Levee Mile Report Line	11
Start Levee Mile	2.13
End Levee Mile	2.13
Location	Crown
Category	Earthen Levee
Item	Encroachments

Drainage discharge to Paradise Cut.

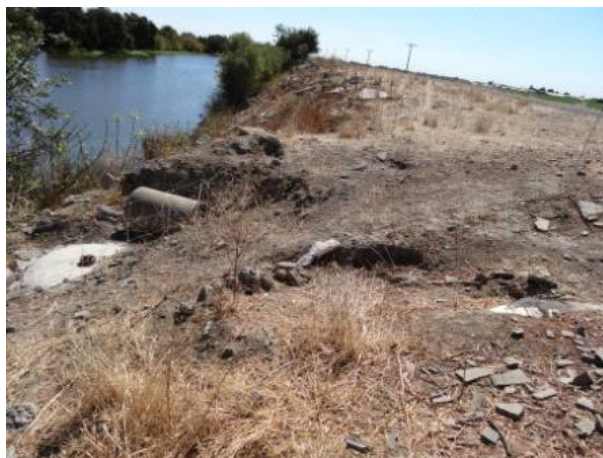
Levee Mile Report Line	12
Start Levee Mile	2.15
End Levee Mile	2.15
Location	Water Side
Category	Supplemental
Item	DWR Erosion Survey

LMR No.	Levee Mile		Category	Item	Location	Rating	Action/Comment	GPS Latitude/Longitude		Issue No.
	Start	End						Start	End	
12	2.15	2.15	Supplemental	DWR Erosion Survey	WS	M	Inspector Comments: 08/28/2013: No significant change observed. 07/31/2012: Site was visited on 07/26/2012. No significant change observed. A new vertical pipe was installed and concrete blocks left on the site. Dense vegetation is visible at the site. No signs of new leaks or spill from the siphon breaker. 09/02/2011: Site was not visited due to the time limit. 09/22/2010: No significant changes observed. Vegetation downstream, upstream and on the lower slope of the site have been recently sprayed. These areas were also fenced off during the site visit, making it difficult for us to examine the condition of the lower slope. Possible leak or spill from the siphon breaker is creating notches along the slope and developing into a headward erosion. If the problem continues, it will erode the slope and fully expose the pipe to outside elements. 07/23/2009: A possible leak or spill from a siphon breaker is eroding the slope and developing into a headward erosion; a portion of the buried pipe is exposed; the lower slope seems to be lined with chunks of concrete debris or other rock material. [2013 Site ID:RD2058U01RM1.78]	37.803769 ° -121.386341 °	37.803769 ° -121.386341 °	1 Y

Direct view of siphon breaker.

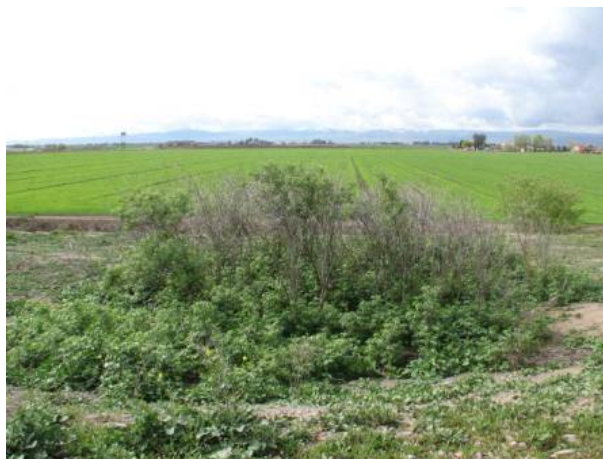
Levee Mile Report Line	14
Start Levee Mile	2.42
End Levee Mile	2.42
Location	Land Side
Category	Earthen Levee
Item	Vegetation

13	2.26	2.33	Earthen Levee	Encroachments	LS	M	DT : Ditch	37.803375 ° -121.384196 °	37.803136 ° -121.383078 °	12
DWR ID: DWR_RD2058_01_f_2013_12										
14	2.42	2.42	Earthen Levee	Vegetation	LS	A/W	V4 : Elderberries are blocking visibility and flood fight capability. Inspector Comments: Elderberry growing on landside toe.	37.802782 ° -121.381413 °	37.802782 ° -121.381413 °	16 Y
DWR ID: DWR_RD2058_01_s_2012_16										
15	2.64	2.64	Earthen Levee	Vegetation	WSA/W	Ma	V4 : Elderberries are blocking visibility and flood fight capability. Inspector Comments: Elderberry on waterside slope.	37.801962 ° -121.377684 °	37.801962 ° -121.377684 °	63 Y
DWR ID: DWR_RD2058_01_s_2012_63										
16	2.66	2.66	Earthen Levee	Vegetation	WSA/W	Ob	V4 : Elderberries are blocking visibility and flood fight capability.	37.801876 ° -121.377291 °	37.801876 ° -121.377291 °	64
DWR ID: DWR_RD2058_01_s_2012_64										
17	2.67	2.67	Earthen Levee	Vegetation	WSA/W	Ob	V4 : Elderberries are blocking visibility and flood fight capability.	37.801823 ° -121.377068 °	37.801823 ° -121.377068 °	65

03/28/2012 Large elderberry bush on landside slope.

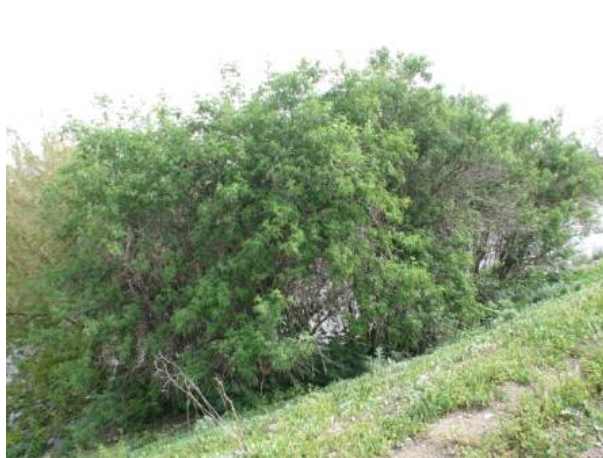
Levee Mile Report Line	15
Start Levee Mile	2.64
End Levee Mile	2.64
Location	Water Side
Category	Earthen Levee
Item	Vegetation

03/28/2012 Large elderberry bush located on waterward slope.

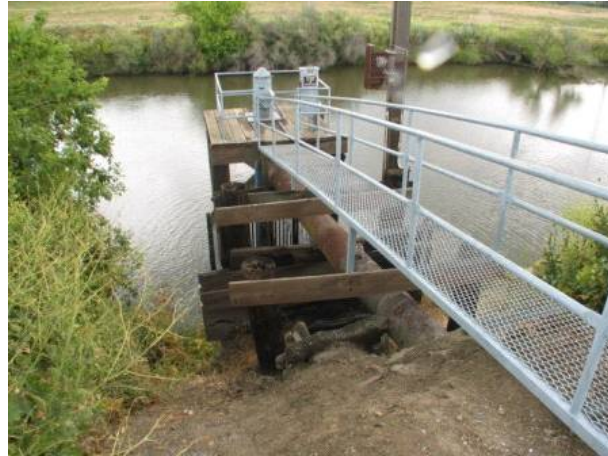
Levee Mile Report Line	20
Start Levee Mile	2.89
End Levee Mile	2.89
Location	Water Side
Category	Earthen Levee
Item	Encroachments

Irrigation intake from Paradise Cut.

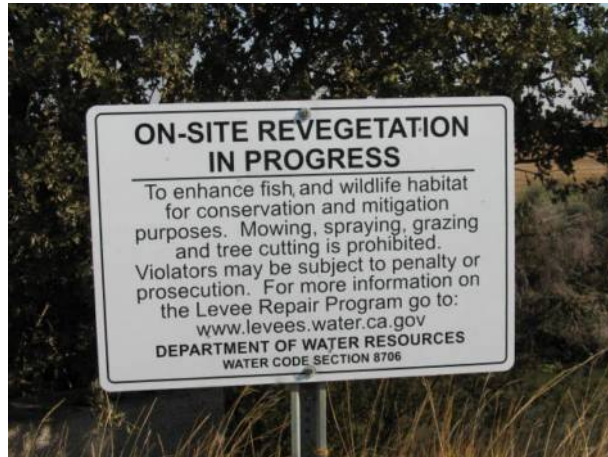
Levee Mile Report Line	25
Start Levee Mile	3.85
End Levee Mile	3.85
Location	Water Side
Category	Earthen Levee
Item	Vegetation

DWR ID: DWR_RD2058_01_s_2012_974										
25	3.85	3.85	Earthen Levee	Vegetation	WSA/W	V8 : Environmental Requirements. Ma	Inspector Comments: Revegetation site.	37.790807 ° -121.362905 °	37.790807 ° -121.362905 °	20 Y
DWR ID: DWR_RD2058_01_s_2012_20										
26	4.01	4.01	Earthen Levee	Vegetation	LS	M Ma	V4 : Elderberries are blocking visibility and flood fight capability. Inspector Comments: Elderberry on landside hinge point.	37.789128 ° -121.361042 °	37.789128 ° -121.361042 °	26 Y
DWR ID: DWR_RD2058_01_s_2012_26										
27	4.01	4.01	Earthen Levee	Vegetation	WSA/W	V4 : Elderberries are blocking visibility and flood fight capability. Ob		37.789096 ° -121.360966 °	37.789096 ° -121.360966 °	69
DWR ID: DWR_RD2058_01_s_2012_69										
28	4.36	4.36	Earthen Levee	Vegetation	WSA/W	V4 : Elderberries are blocking visibility and flood fight capability. Ob		37.789794 ° -121.354883 °	37.789794 ° -121.354883 °	71

11/08/2011 Revegetation site, cannot trim or cut vegetation in this area.

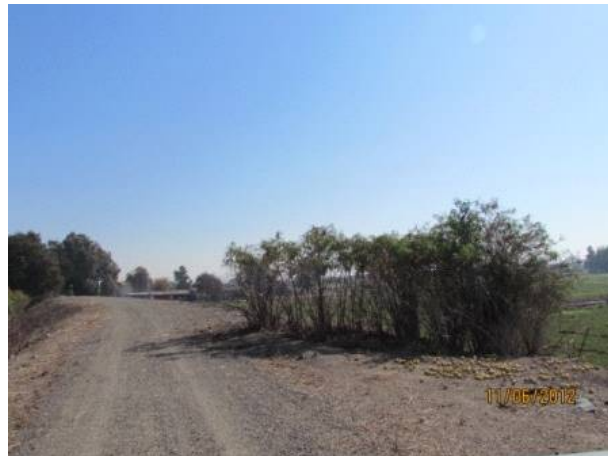
Levee Mile Report Line	26
Start Levee Mile	4.01
End Levee Mile	4.01
Location	Land Side
Category	Earthen Levee
Item	Vegetation

Elderberry bushes on landside slope.

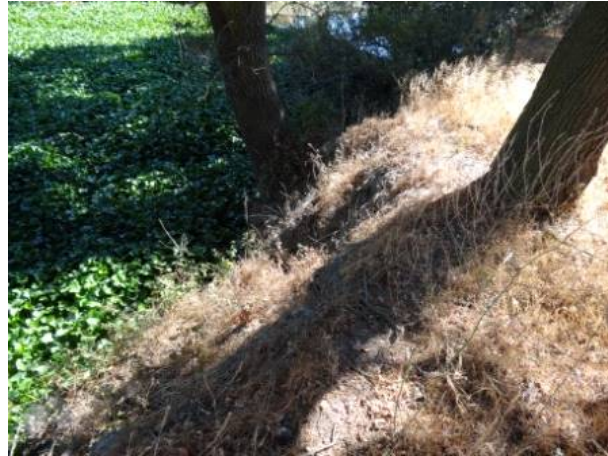
Levee Mile Report Line	29
Start Levee Mile	4.49
End Levee Mile	4.53
Location	Water Side
Category	Supplemental
Item	DWR Erosion Survey

LMR No.	Levee Mile		Category	Item	Location	Rating	Action/Comment	GPS Latitude/Longitude		Issue No.
	Start	End						Start	End	
29	4.49	4.53	Supplemental	DWR Erosion Survey	WS	M Ma	Inspector Comments: 08/28/2013: No significant change observed. 07/26/2012: The site has been visited, and no significant change has been observed. 09/02/2011: This site was not visited due to the time limit. 09/22/2010: No significant changes observed. Minor pocket erosions are lined at the lower bank. Two large Oak and Willow trees are on mid-slope and bench. The remaining bench was re-measured and found to be approximately 10 feet. There was no indication of active erosion on site during the site visit. 08/05/2010: Recommended for annual assessment and monitoring of site during flood events, per CLRO. 07/23/2009: No major change observed since last visit; site is a 200-ft. long near-vertical berm erosion; recommend annual assessment and monitoring of erosion site, per CLRO CES Evaluation 2008 Report; Site # is the same site previously reported as RM4.0,LM4.51; previously rated "U". 09/10/2008: Two large trees (2-3' DBH) with partial roots exposed. 2007: Visited site 03/13/2007. [2013 Site ID:RD2058U01RM3.97]	37.789810 ° -121.352490 °	37.789810 ° -121.352490 °	2 Y

Direct view of the erosion near a tree.

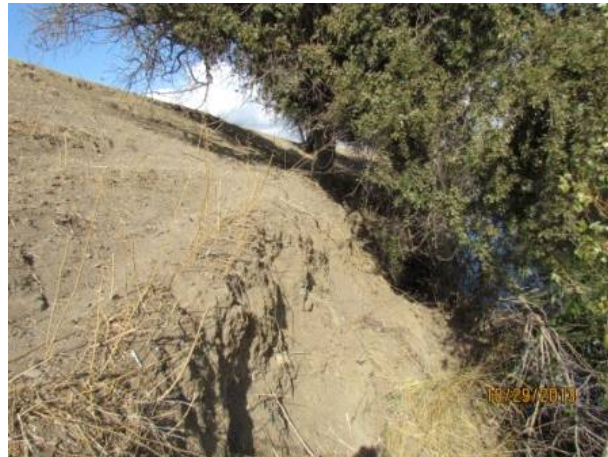
Levee Mile Report Line	30
Start Levee Mile	4.82
End Levee Mile	4.82
Location	Water Side
Category	Earthen Levee
Item	Erosion / Bank Caving

DWR ID:										
30	4.82	4.82	Earthen Levee	Erosion / Bank Caving	WS	U Ma	E1 : Note and monitor erosion site. Inspector Comments: The erosion has about a 3 foot vertical cut at the waterside levee toe.	37.785862 ° -121.350303 °	37.785862 ° -121.350303 °	15 Y
DWR ID: DWR_RD2058_01_f_2013_15										
31	5.16	5.16	Earthen Levee	Encroachments	LS	U En	RA : Ramp Inspector Comments: New ramp construction connecting dairy to levee. Construction of ramp results in a new pond on the landside of the levee. 2/21/2012, owner has said that he will contact the CVFPB to resolve this issue.	37.783102 ° -121.345682 °	37.783102 ° -121.345682 °	29 Y
DWR ID: DWR_RD2058_01_s_2012_29										
32	5.37	5.37	Earthen Levee	Encroachments	LS	U En	RA : Ramp Inspector Comments: Ramp constructed to dairy. Raised ramps, see issue 29 are creating new holding ponds for dairy at levee toe.	37.782268 ° -121.342257 °	37.782268 ° -121.342257 °	30 Y

View of the erosion at the waterside levee toe.

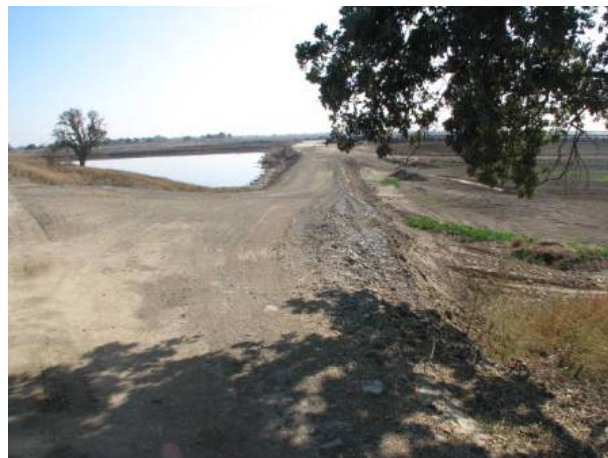
Levee Mile Report Line	31
Start Levee Mile	5.16
End Levee Mile	5.16
Location	Land Side
Category	Earthen Levee
Item	Encroachments

11/08/2011 New ramp has been constructed by Dairy farmer connecting his barns to the levee.

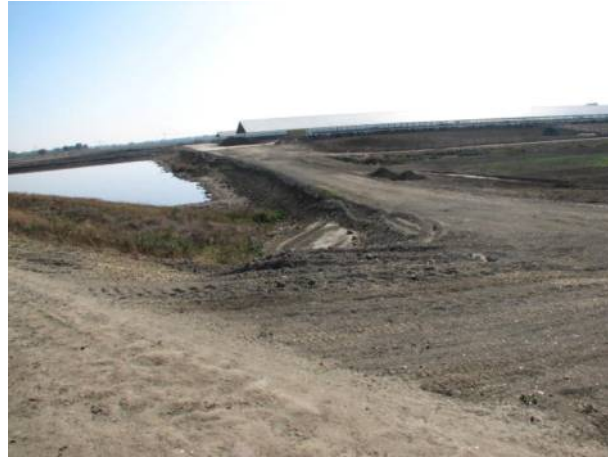
Levee Mile Report Line	31
Start Levee Mile	5.16
End Levee Mile	5.16
Location	Land Side
Category	Earthen Levee
Item	Encroachments

11/08/2011 New ramp has been constructed by Dairy farmer connecting his barns to the levee.

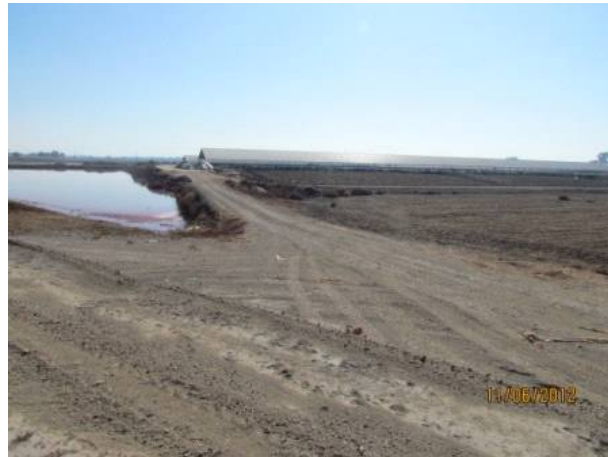
Levee Mile Report Line	31
Start Levee Mile	5.16
End Levee Mile	5.16
Location	Land Side
Category	Earthen Levee
Item	Encroachments

Completed new ramp constructed by Dairy farmer connecting his barns to the levee.

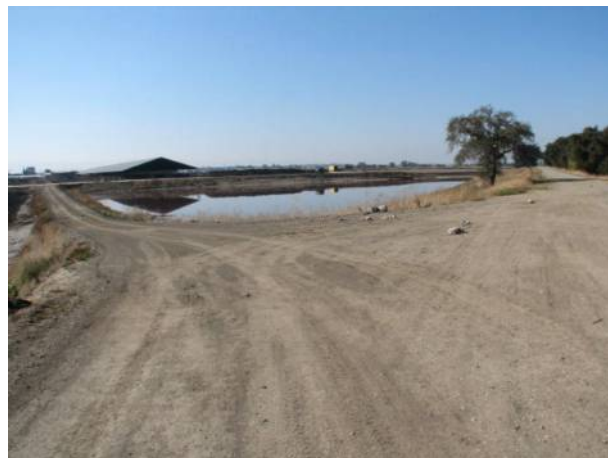
Levee Mile Report Line	32
Start Levee Mile	5.37
End Levee Mile	5.37
Location	Land Side
Category	Earthen Levee
Item	Encroachments

11/08/2011 Photo shows existing middle ramp to the levee which has been raised.

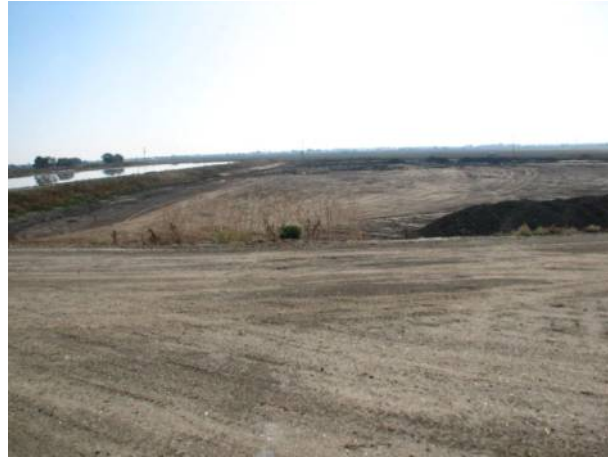
Levee Mile Report Line	32
Start Levee Mile	5.37
End Levee Mile	5.37
Location	Land Side
Category	Earthen Levee
Item	Encroachments
11/08/2011 Photo shows view from the levee looking to the left of the middle ramp.	
mkhashch_f_20130923_231.jpg

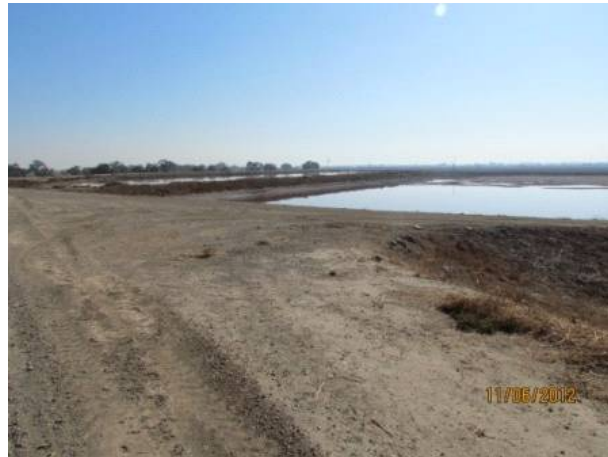
Levee Mile Report Line	32
Start Levee Mile	5.37
End Levee Mile	5.37
Location	Land Side
Category	Earthen Levee
Item	Encroachments
Completed new ramp constructed by Dairy farmer connecting his barns to the levee.	
mkhashch_f_20130923_232.JPG
